FIG. 255.—LOWER DAM, OR "PRESA DE LA OLLA," GUANAJUATO, MEXICO. VIEW TAKEN DURING THE FEAST DAY WHEN THE GATES ARE RAISED AND THE RESERVOIR EMPTIED.

The chapter on Masonry Dams has been increased twofold by an attempt to make some mention of all the most notable dams of the world, and many that are very little known. Attention is particularly directed to Plates 1, 2, and 3, in which profiles are shown of all of the leading and better known masonry dams in existence, drawn to uniform scale for easy graphical comparison. No such complete collection of dam profiles has ever before appeared in print, assembled together on a common basis.

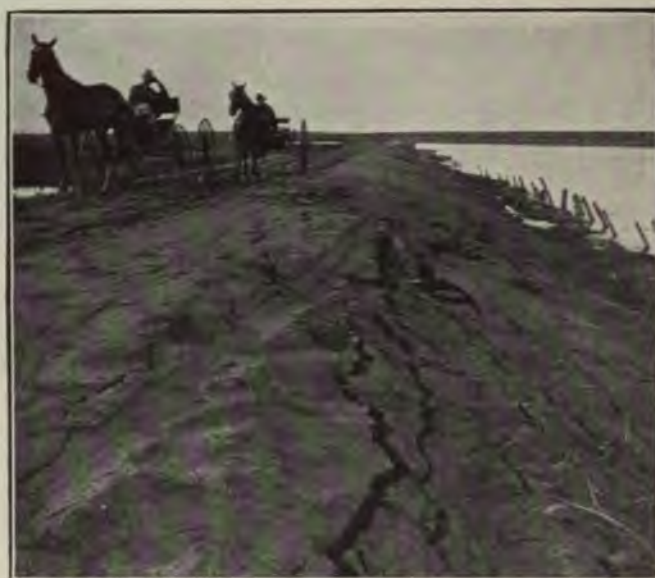
FIG. 333.—DOUGLAS LAKE DAM, COLORADO, SHOWING DANGEROUS SETTLEMENT CRACKS, DUE TO IMPROPER METHOD OF CONSTRUCTION.

The Douglas Lake Reservoir, Colorado.—An earth dam across a natural depression on Dry Creek, five miles northwest of Fort Collins, Col., was built in 1902, an illustration of which is shown in Fig. 333.

The great cracks in the dam are the conspicuous feature of the picture, and are evidence of the lack of proper care and supervision in important works of this character. The dam contains about 150,000 cubic yards of earth, and forms a reservoir of 10,600 acre-feet capacity, sufficient to create great havoc in the country below it if it were suddenly released. The reservoir is filled by a ditch from the North Poudre river.

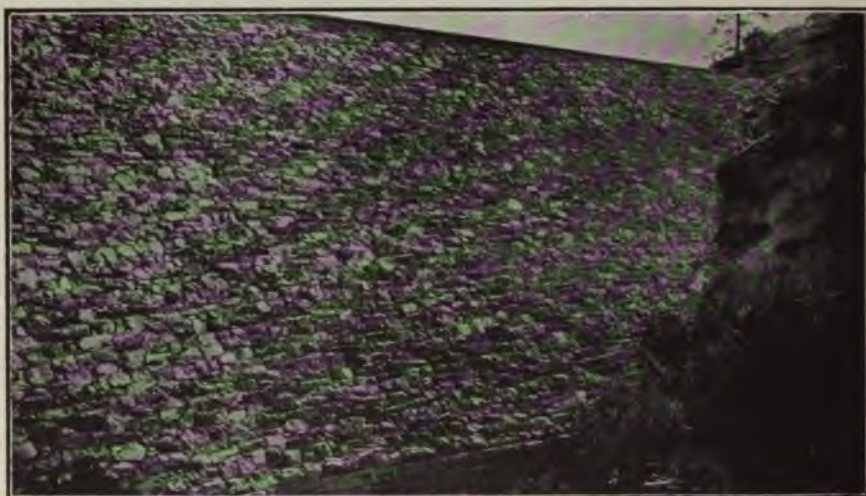
FIG. 338.—DOWN-STREAM FACE OF BOWMAN LAKE DAM, CALIFORNIA, ILLUSTRATING THE QUALITY OF THE DRY MASONRY.

The Bowman Rock-fill Dam.—Renewed interest is being taken in the old rock-fill dams of the Sierra Nevada Mountains, in Northern California, built originally to store water for hydraulic mining, because they are becoming valuable for the double uses of generating power and affording domestic and irrigation supply to the valley below. The Bowman dam, described on page 65, and outlined by cross-sections, Fig. 44, is more clearly illustrated in its situation and construction by Figs. 336, 337, 338, 339, and 340.

17,000 cubic yards of stone filling, 33,000 lineal feet of heavy timber, and 63,000 feet, B. M., of three-inch plank. It was actually designed to carry flood water over its crest to a depth of 3 feet for a length of 300 feet in emergency. The main spill-way, however, is an entirely separate structure, as described later. Before this work was finally completed it was destroyed by fire, October 12, 1871, and again damaged, or practically destroyed, by flood at the end of the same year. In 1872 it was rebuilt to a height of 65 feet, after the same plan as before, with flash-boards on the crest, raising its height to a total of 72 feet. The final increase in height was made, and the dam completed as it now stands, December 10, 1876. Its height has always been called 100 feet in round numbers, but its actual measure is 96 feet at the highest point.

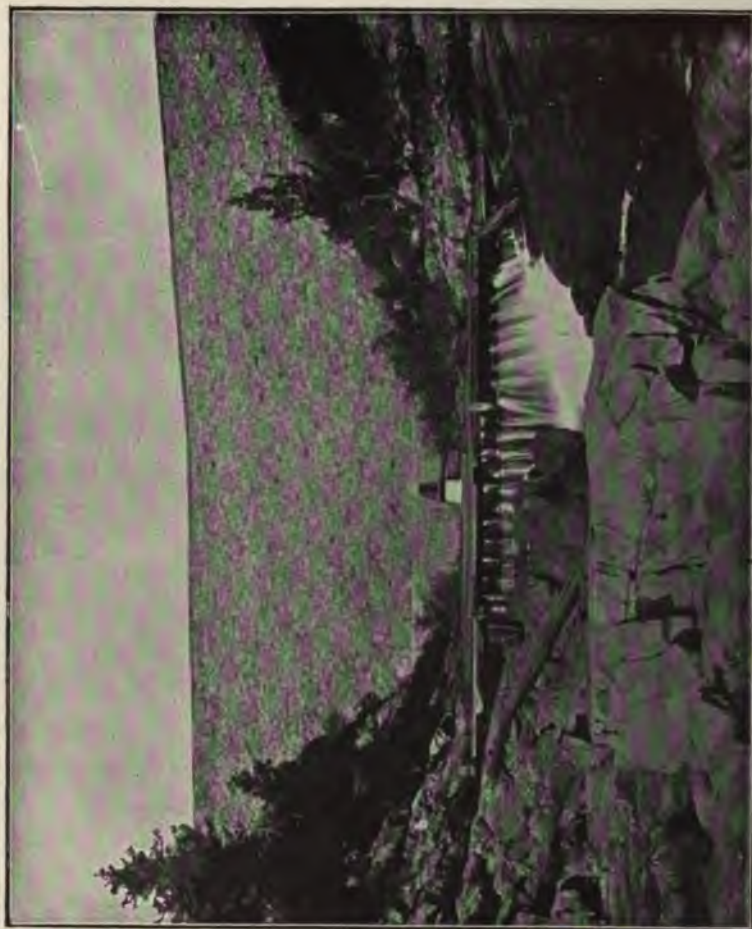
FIG. 339.—FRONT VIEW OF BOWMAN LAKE DAM, FROM BELOW MEASURING WEIR.

the first layer of plank is placed horizontally and not vertically as before. At the base the 3-inch plank are in three layers; at the top is but one layer. The plank facing of the lower half of the dam, laid in 1876, is still serviceable after thirty-two years of wear. The upper half of the planking has been replaced once. Since the dam was built, in 1876, there has been a sag in its center amounting to about 12 inches, due to the decay of the timber in the cribs and the settlement of the rock.

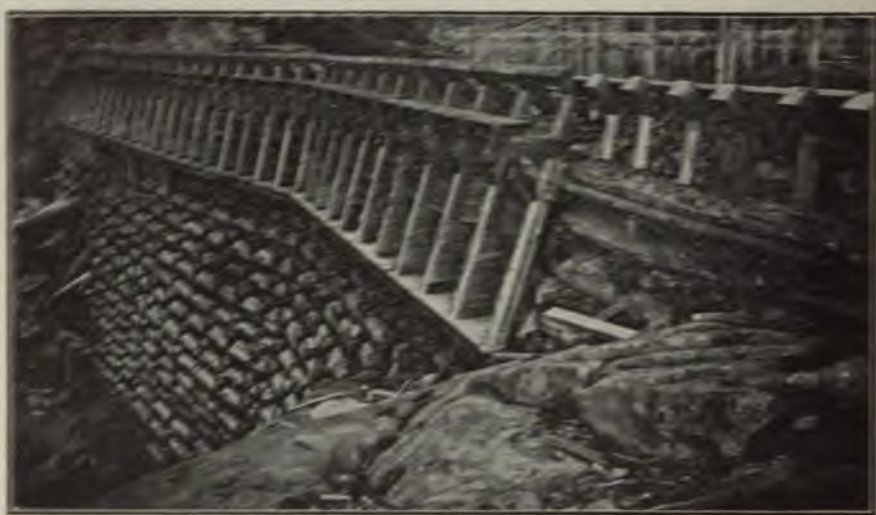
FIG. 340.—TIMBER CRIB SPILLWAY OF BOWMAN LAKE DAM. THIS STRUCTURE IS 52 FEET HIGH.

Spillway.—While the main dam was intended to act as an emergency overflow, or spillway, the principal spillway is a separate structure (Fig. 340), 52 feet high, built of round logs fastened together by 1-inch drift bolts, forming a crib, filled with small stone. This structure is also covered with a skin of 3-inch plank on the water side, and has a slight angle pointing up stream. The crest is 12 feet lower than the crest of the main dam. It is arranged with A-frame bents so that flash-boards may be added to raise the water 8 feet. There are thirty-one openings

between bents, each 4 feet wide. During the flood season the flash-boards are removed, but when all danger of floods is supposed to be past these wasteways are closed with 2-inch loose planks. This structure, built in 1876, has had little or no repair since that date, and has sagged very perceptibly. The ends of the main timbers are torn from the walls of the canyon, and the header logs have rotted to a soft pulp at their extremities, where exposed to the weather. The water passing through or over this spillway leaps clear of the log face on the downstream side, otherwise it would not have lasted as long as it has.

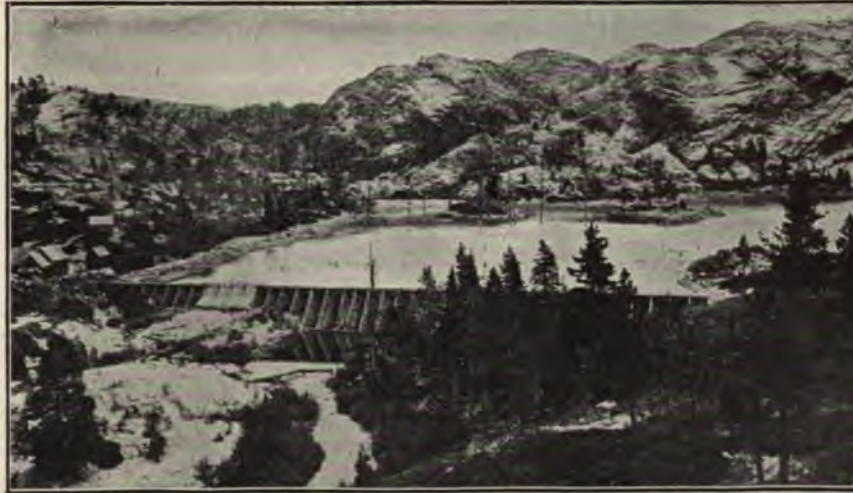
FIG. 341.—THE FAUCHERIE DAM, CALIFORNIA. A GENERAL VIEW OF DAM AND RESERVOIR.

rebuilt with a reduced maximum height of 21 feet (see Figs. 341 and 342). The frame supporting the inclined face is triangular in form, leaning

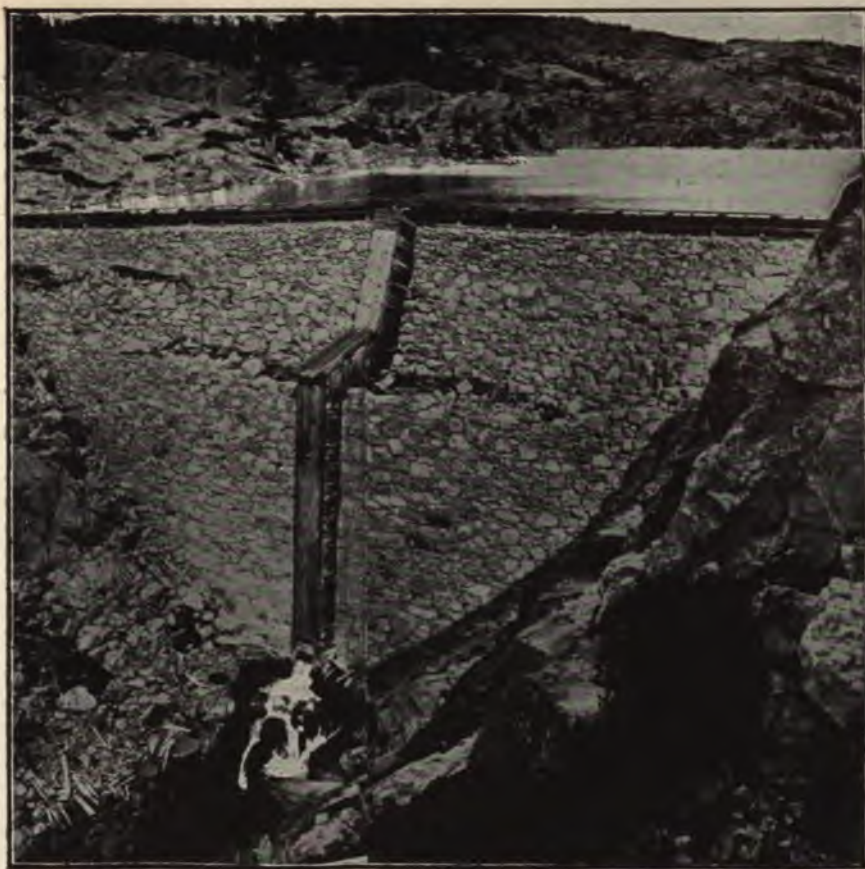
FIG. 343.—THE EUREKA LAKE ROCK-FILL DAM, CALIFORNIA, SHOWING COVERED MAN-
WAY TO REACH GATES FROM CREST IN WINTER.

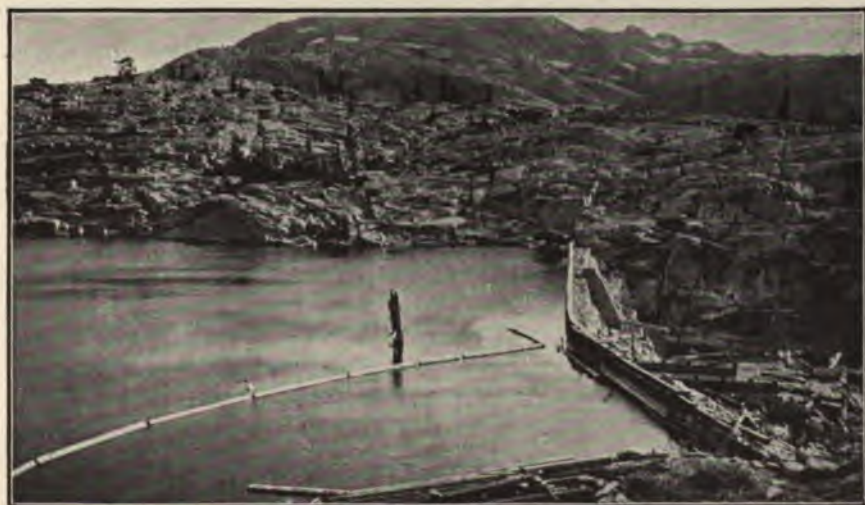
FIG. 344.—SHOWING THE CREST OF THE EUREKA LAKE ROCK-FILL DAM, AND A PORTION
OF THE LAKE.

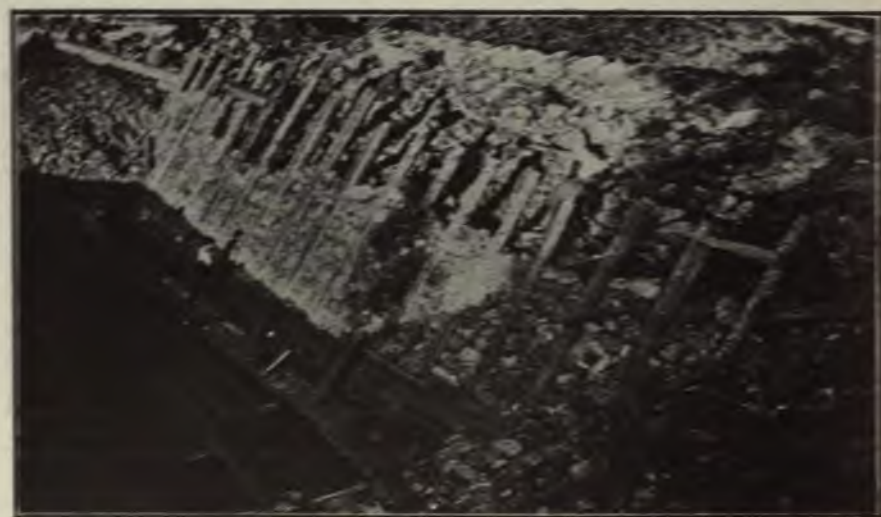
FIG. 345.—THE WEAVER LAKE DAM, CALIFORNIA, SHOWING RECENT CONSTRUCTION.

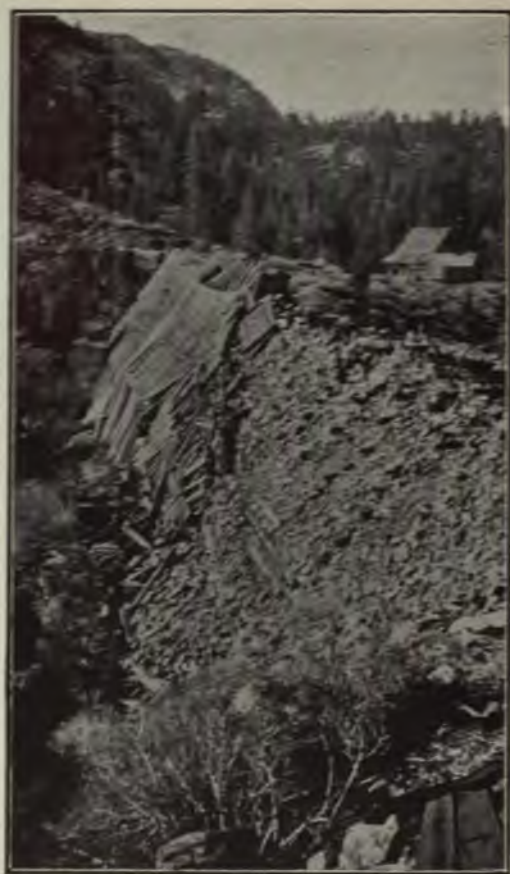
FIG. 346.—UP-STREAM FACE OF ONE OF THE TWO REMAINING ROCK-FILL STRUCTURES WHICH, WITH THE THIRD STRUCTURE DESTROYED IN 1883, ORIGINALLY FORMED THE ENGLISH LAKE DAM.

The English Dam.—On pp. 63-64 the high rock-fill structure known as the English Dam is described, with an account of the bursting and destruction of the main dam, the central one of three which formed the reservoir. Figs. 346, 347, and 348 illustrate the style of construction and present condition of the principal one of the two remaining dams.

The existing dams both have a crest extension of wood, 6 feet high, of similar construction. (See Figs. 346 and 347.) This is also well illustrated by Fig. 348, showing the dry wall laid up on the down-stream face.

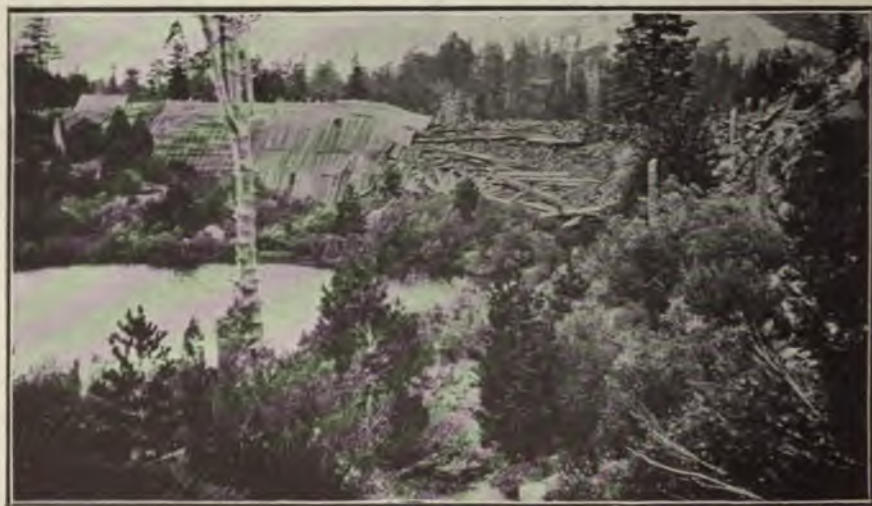
FIG. 347.—GENERAL VIEW OF THE TIMBER SKIN ON UP-STREAM SIDE OF THE ENGLISH LAKE DAM. NOW IN RUIN.

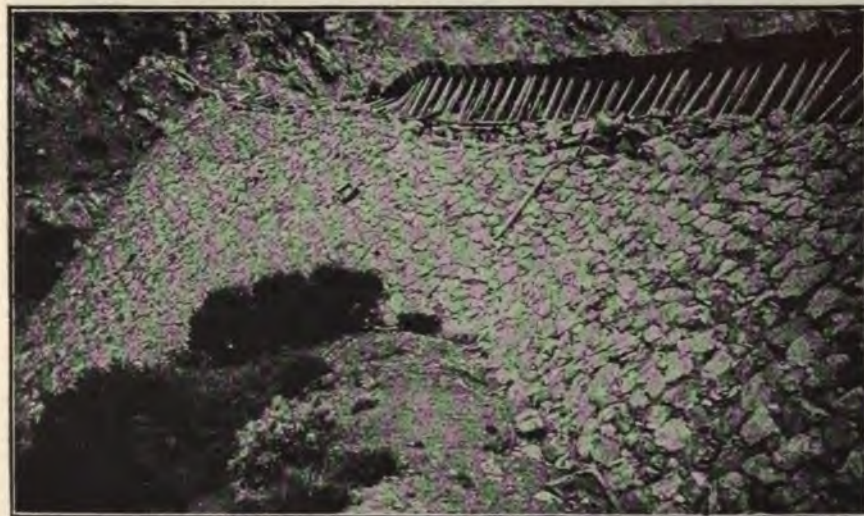
FIG. 348.—THE DOWN-STREAM FACING OF THE ENGLISH LAKE DAM, CONSISTING OF A HAND-LAID DRY WALL IS WELL ILLUSTRATED BY THIS PHOTOGRAPH.

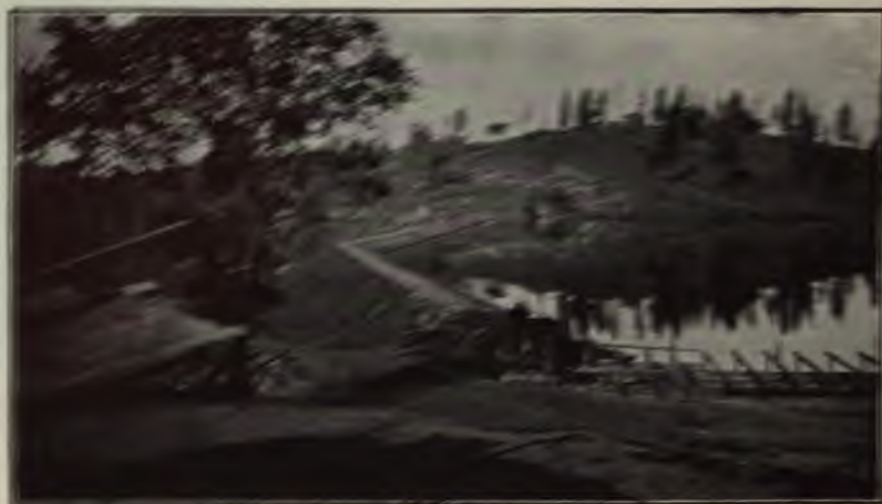
FIG. 349.—THE LAKE FRANCES HYDRAULIC-FILL DAM AS COMPLETED AND IN SERVICE, SHOWING NEW SPILLWAY AND GATES IN FOREGROUND.

The Lake Frances Dam.—All of the photographs accompanying the description of the Lake Frances hydraulic-fill dam on pp. 115 to 125 were taken during construction and before its final completion. Fig. 349, however, is a recent view taken in 1907, showing the finished dam in service. In the foreground is seen a secondary spillway and controlling-gates, added since the dam was completed. This is a wooden flume, 16 feet wide, 6 feet deep below the water-line, the apparent object of which was to allow them to begin wasting water before the lake filled to its full depth at the main spillway level.

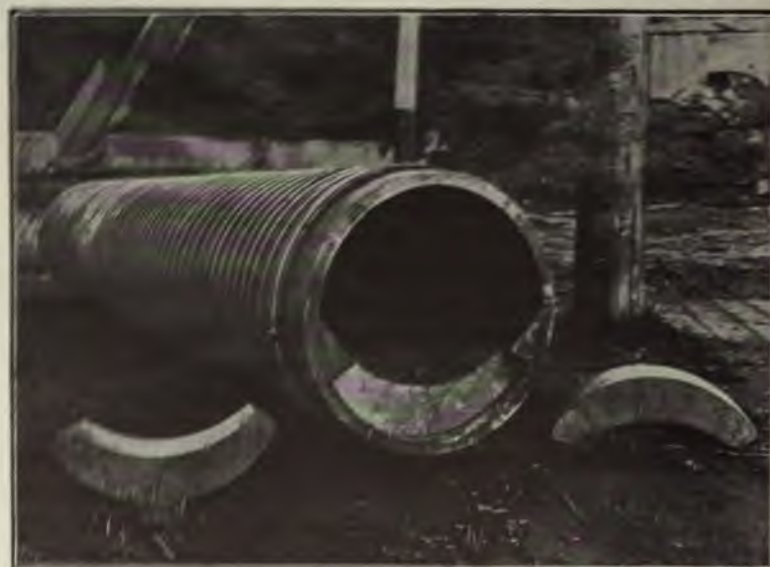
FIG. 350.—THE HOPKINS WOOD PIPE, FOR CARRYING GRITTY MATERIAL, THE WEAR BEING UPON THE END GRAIN OF THE WOOD.

appliances that have been used on this work, which has been in progress several years, and the methods that have been evolved have a direct bearing upon the construction of hydraulic-fill dams by the same agency, they are of very positive interest, and the illustrations in Figs. 350, 351, 352, 353, and 354 are most acceptable additions to this book.

hill consisted mostly of sand and gravel, some few feet from the top a difficult bank of hard blue clay was encountered. In spite of this complication from 500 to 2000 cubic yards of earth were sluiced out each twenty-four hours, using from 2,000,000 to 8,000,000 gallons of water. The water was carried from a reservoir situated more than half a mile from the work. The grade was such, however, that it gave 60 to 80 pounds pressure. The spoil was carried by the Hopkirk Patent Pipe. This is a stave wooden pipe with a reinforced bottom which can be renewed when worn out. The reinforced bottom is made of fir with the end grain of the wood faced so as to withstand the wear of the spoil.

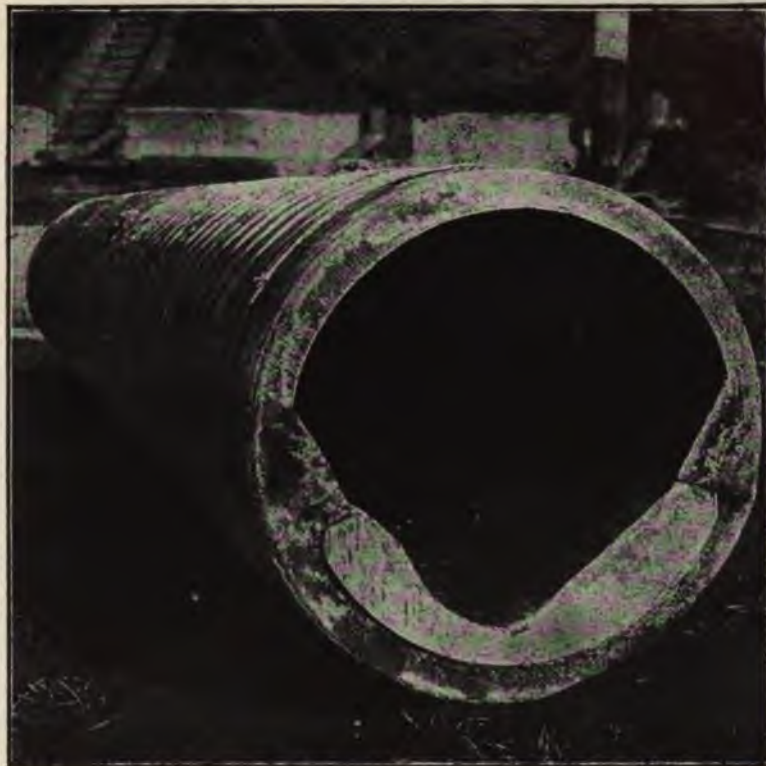
FIG. 351.—THE HOPKIRK PIPE, AFTER SIX AND ONE HALF MONTHS WEAR ON 20% GRADE, IN SEATTLE.

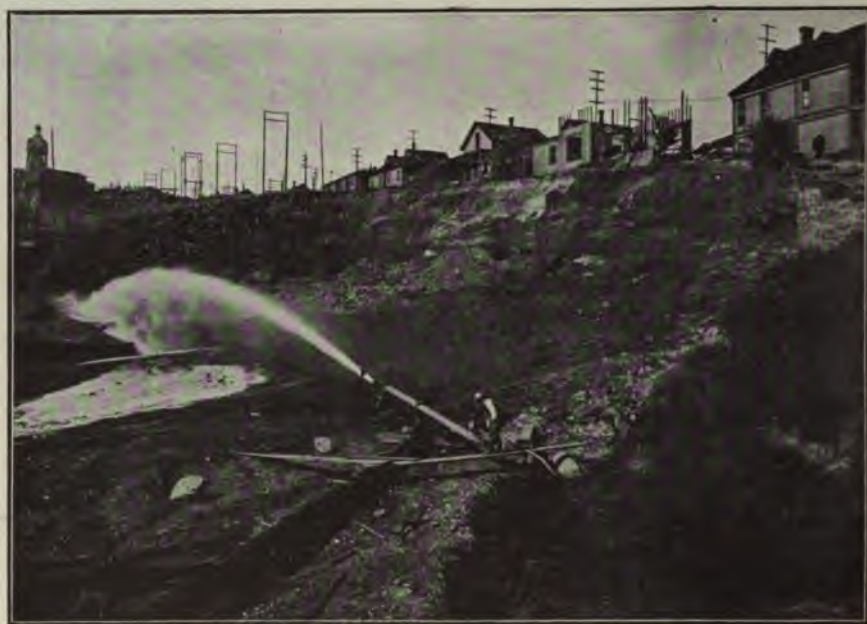
FIG. 352.—THE REGRADING OF JACKSON STREET, SEATTLE, LOOKING NORTH ON MAYNARD STREET. THE HOUSES ARE REMOVED JUST BEFORE THEY ARE UNDERMINED.

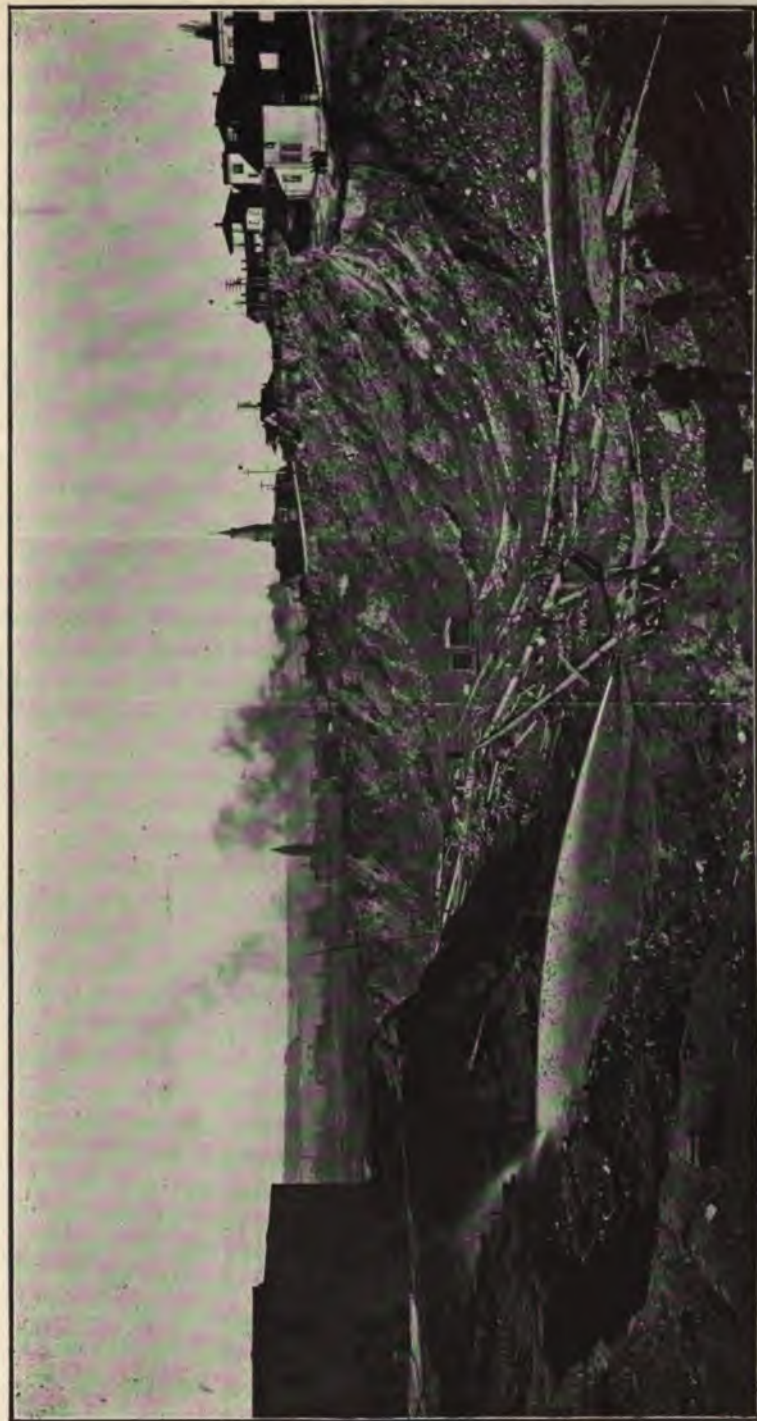
FIG. 353.—THE JACKSON STREET REGRADE BY HYDRAULIC SLUICING, WITH WATER PUMPED.

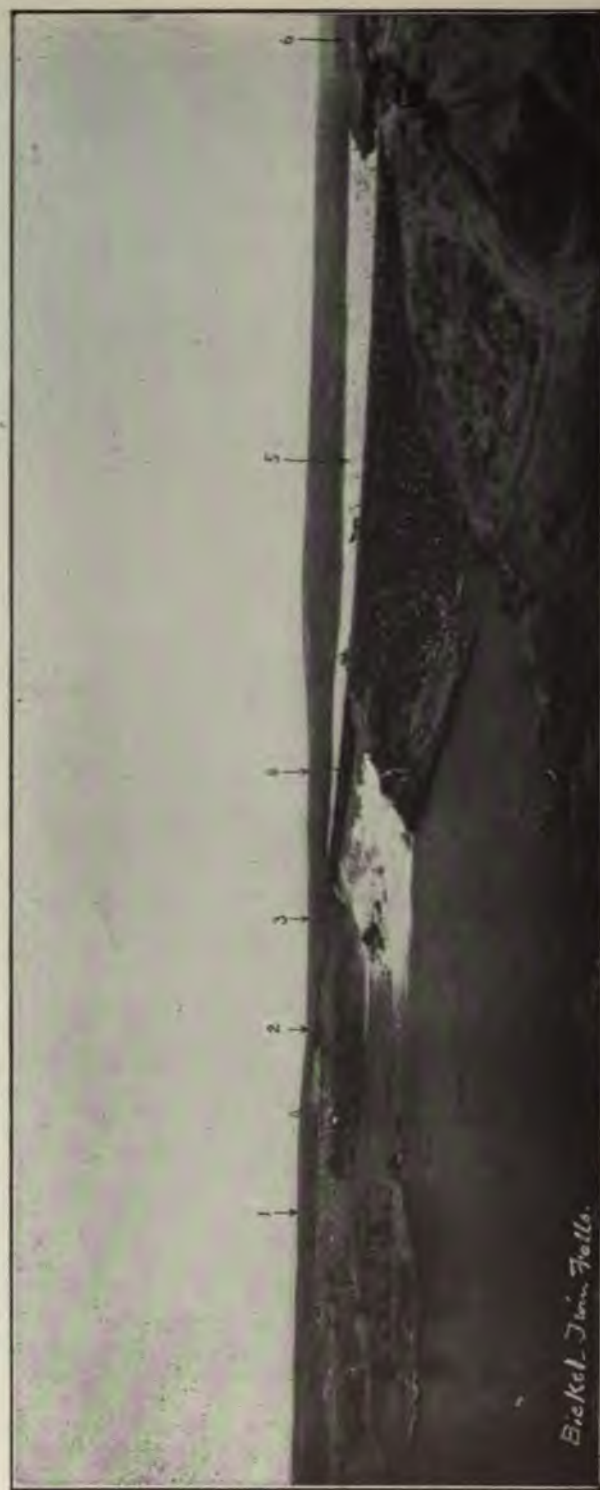
FIG. 355.—THE MILNER DAM, SNAKE RIVER, IDAHO, ON THE TWIN FALLS CANAL PROJECT.

Arrows: 1 indicates the main channel dam; 2, the North Island spillway; 3, the middle dam; 4, the South Island regulating-gates; 5, the south dam; 6, the head-gates of Twin Falls Canal.

The Milner Dam, Idaho.—The photograph shown in Fig. 355 gives a more comprehensive picture of the three combination dams described on page 60 than any of the other illustrations accompanying the article (see Figs. 47 to 53), and will therefore add to the interest in these important and successful dams.

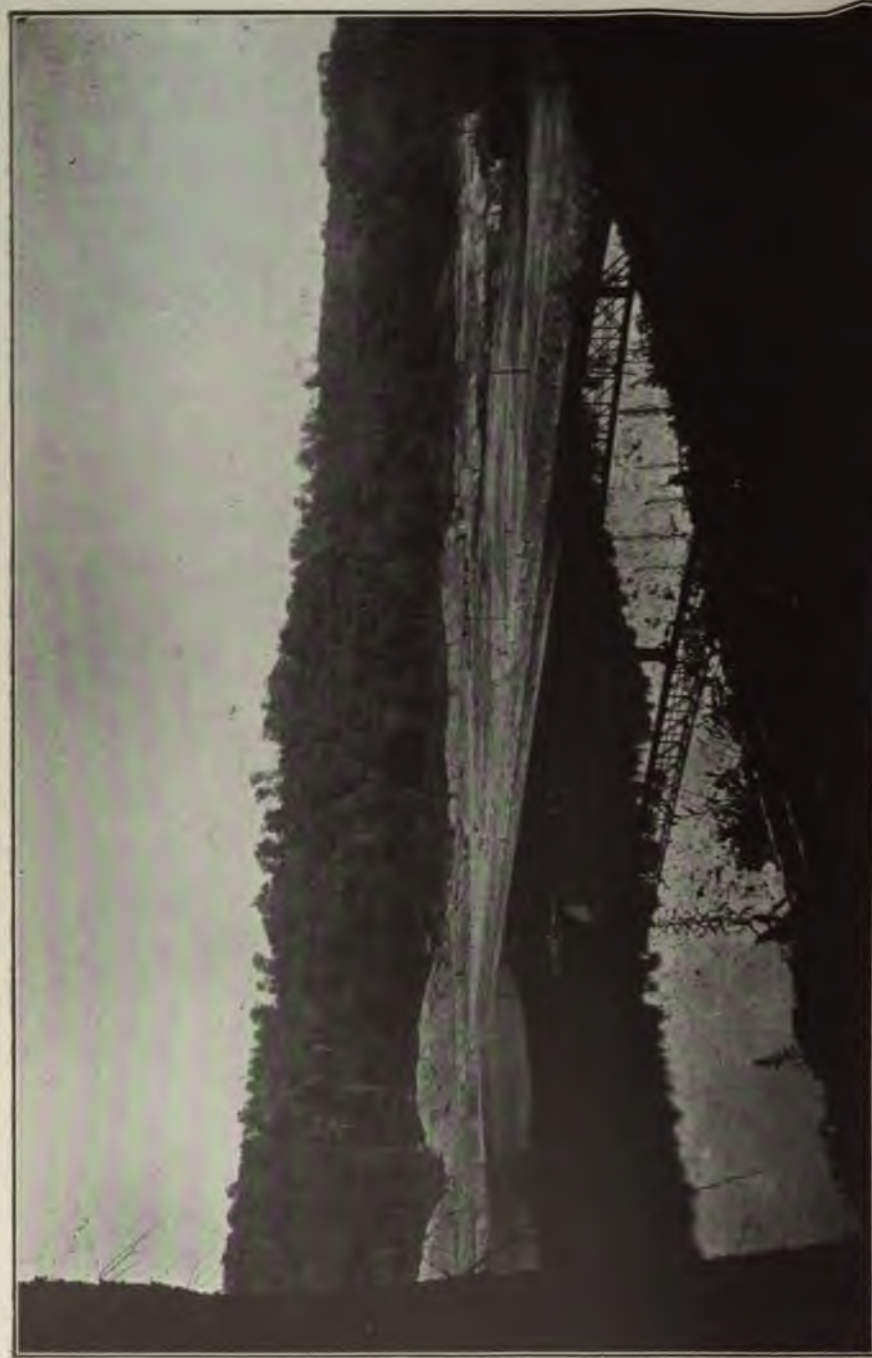
FIG. 358.—THE HINKSTON RUN DAM, CAMBRIA STEEL WORKS, JOHNSTOWN, PA.

It is essentially an earth embankment with concrete core-wall extending from bed-rock up to about one-third the height, or 45 feet below the water-line. The unique feature of the dam is the heavy reinforcement given to it by a backing of cinders, the waste product of the blast-furnaces of the Cambria Steel Works. This cinder-fill is to eventually give the dam a minimum crest width of 500 feet. It is now 300 feet wide at the minimum, and 1000 feet at the widest place. The illustration, Fig. 360, gives a clear idea of the plan of construction. The dimensions are as follows:

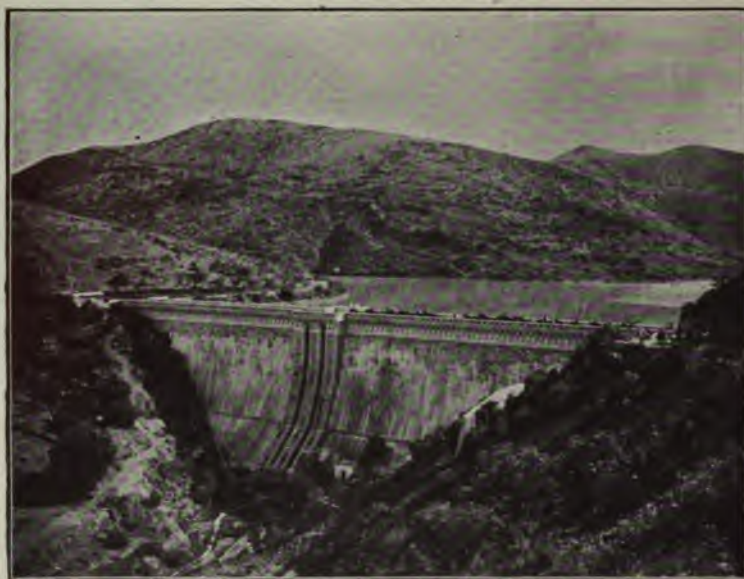
FIG. 362.—GENERAL VIEW OF THE ESPERANZA DAM AND RESERVOIR, NEAR GUANAJUATO, MEXICO.

An excellent general view of the dam and its reservoir of 462 acres is given by the accompanying cut, Fig. 362, which shows the three buttresses, each 9.87 feet square, which extend from bottom to top. These were designed as an ornamental feature, primarily, but serve to

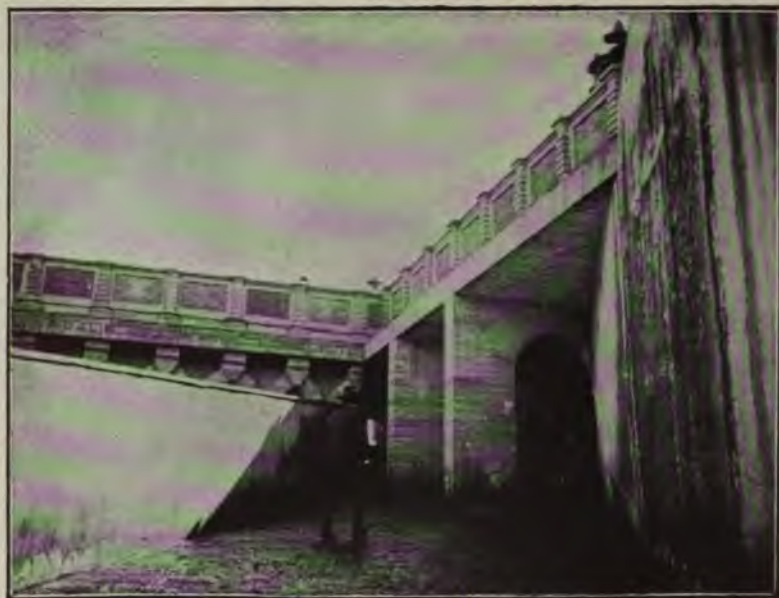
FIG. 365.—THE SPILLWAY CHANNEL OF THE ESPERANZA DAM, AT ITS UPPER END, SHOWING OBSTRUCTIONS TO FREE DISCHARGE BY PIERS SUPPORTING ROADWAY.

somewhat obstructed by the masonry piers supporting the roadway on the top of the dam, as seen in Fig. 365.

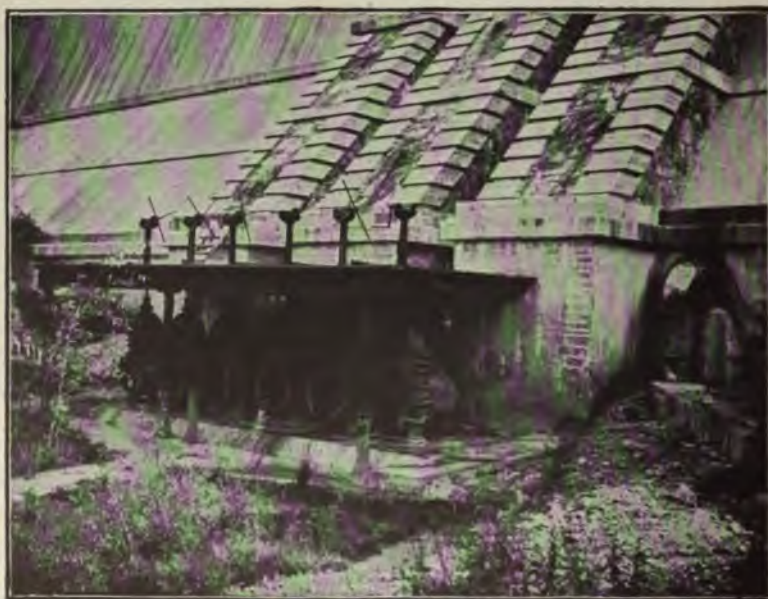
FIG. 366.—THE SIX OUTLET PIPES AND GATE-VALVES OF THE ESPERANZA DAM, BEFORE CONNECTION WITH WATER MAINS OF CITY.

The outlet-gates of the reservoir are six in number, located under the buttresses. They each have a clear diameter of $28\frac{1}{2}$ inches, and are controlled by gate-valves operated by hand windlasses, as shown by Fig. 366. They are in sets of three, each set being attached to one of two wrought-iron pipes, 4 feet 6 inches in diameter, which pass through the masonry of the dam.

The gates are wholly unprotected, except by a light wooden platform which serves merely as a means of access to the operating mechanism. Any injury to the gates would have disastrous consequences, as they cannot be repaired or adjusted except by wholly emptying the reservoir.

The small pipe shown in the angle between the buttress and the dam is a cast-iron pipe $15\frac{1}{2}$ inches outside diameter, which passes through a tunnel in the dam to a standpipe in the reservoir. This standpipe has seven openings from the reservoir, at varying levels, each controlled by a separate valve which is operated by mechanism mounted on a tower reached by a bridge from the center of the dam. This appears to be the main supply-pipe to the city, and its exposed condition is a matter of remark.

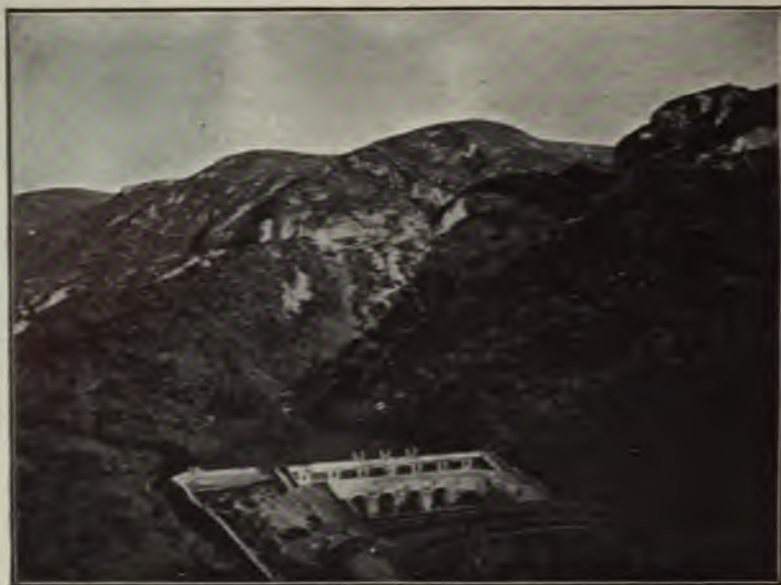
FIG. 367.—THE UPPER OLLA DAM, GUANAJUATO, MEXICO.

Fig. 367 is a distant view of the Upper Olla dam, while Fig. 368 shows the Lower dam, both of which combine many architectural effects with their utility as storage dams. The crest of each serves as a promenade as well as a flood-discharge spillway. A small volume of water wasting passes under the footway without flooding the crest, while a larger discharge passes over the footway. In either event the waste waters pass into a pit close to the down-stream toe of the dam, and out through a tunnel under the park to a lower point of discharge into the stream-bed.

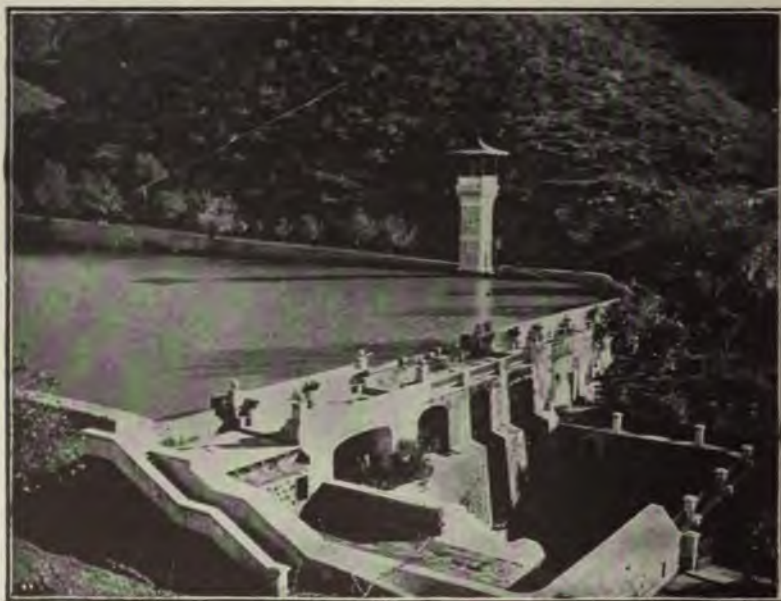
FIG. 368.—THE LOWER OLLA DAM, GUANAJUATO, MEXICO. (See also frontispiece.)

The arched and aqueduct-like appearance of the face of the dam is

due to the fact that the up-stream face is a wooden barrier of flash-boards, removable in times of extreme flood.

The width of the lower dam at the crest is 19 feet, and its length about 300 feet. An angle of 45° down stream exists in the alignment of the lower dam.

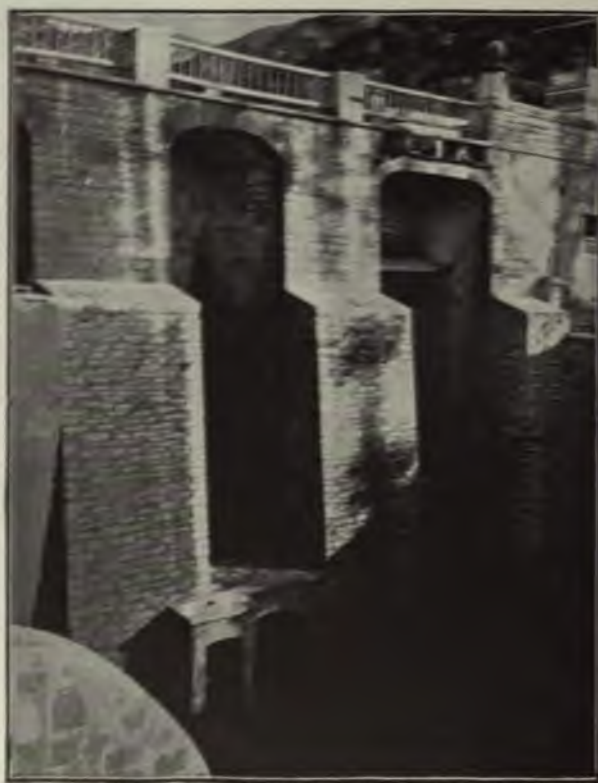
FIG. 370.—A DETAIL OF THE DOWN-STREAM FACE OF THE LOWER OLLA DAM, GUANAJUATO. These openings are closed by a form of movable flash-board.

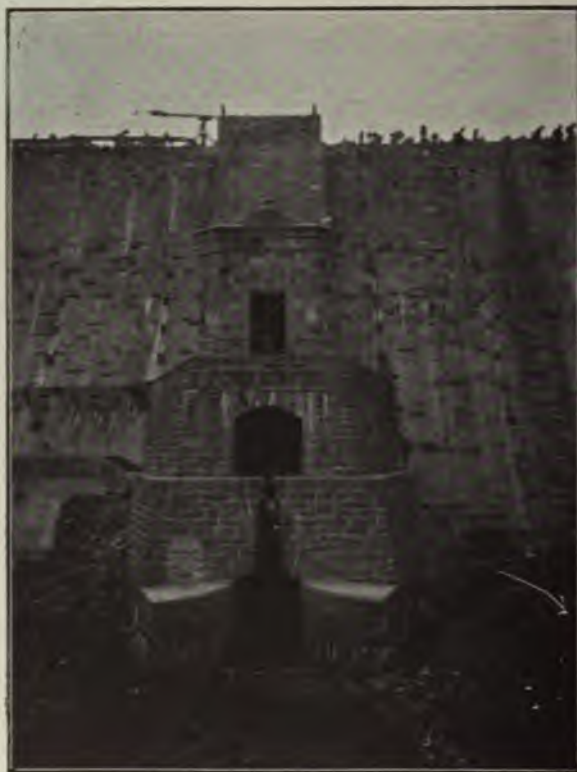
FIG. 372.—ONE OF THE TWO GATE-HOUSES OF THE SAN JOSÉ DAM, SAN LUIS POTOSÍ, MEXICO.

adding to the architectural effect. The lower part of one of these is shown in Fig. 372. They are massive and of generous dimensions. One of them was designed to be surmounted by a statue of a lion on a pedestal.

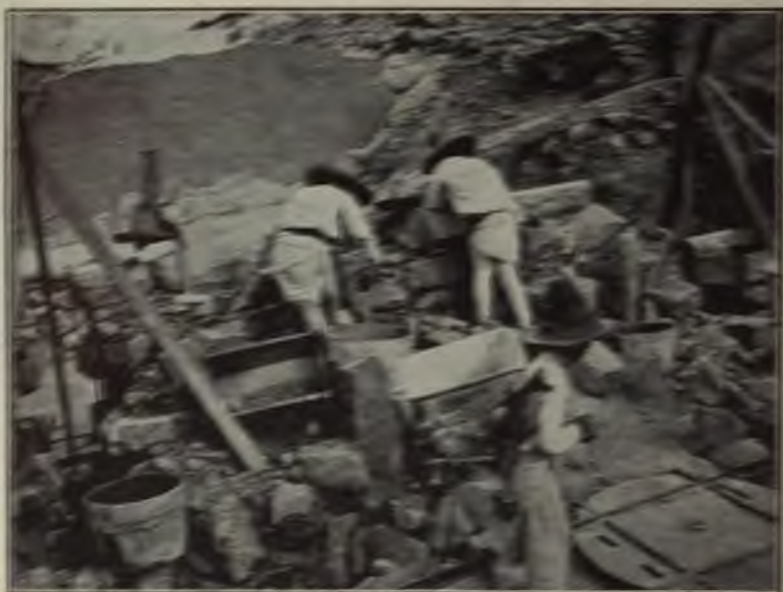
FIG. 374.—Masons at Work on the San José Dam, Mexico.

The San José Dam, San Luis Potosi, Mexico.—In 1901, at the time the photographs shown in Figs. 371, 372, 373, 374, and 375 were taken, a private company was engaged in building a high masonry dam for the storage of water to supply the city of San Luis Potosi and to irrigate land in its vicinity. The city is a stockholder in this corporation. The dam as subsequently completed has an extreme length on the crest of 592 feet, and a maximum height of 151 feet from the lowest foundation to the crest, or 110 feet from the stream-bed to the top. Its thickness at the base is 128 feet, and at the crest about 15 feet.

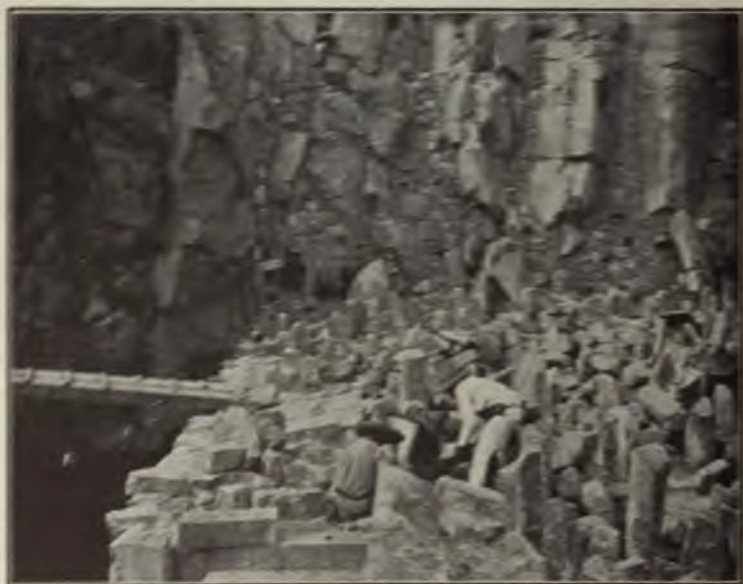
FIG. 375.—ILLUSTRATING THE BONDING OF THE MASONRY OF THE SAN JOSÉ DAM MEXICO.

the base on the up-stream side, and near the top on the down-stream face. In plan the dam is slightly curved up stream with a radius of 2000 metres (6560 feet). It is built of uncoursed rubble masonry, with no stone larger than two men can conveniently carry and mostly of one-man-stone. The bonding of this rubble with long vertical headers is clearly shown in Fig. 375. The two faces are laid in well-cut stone.

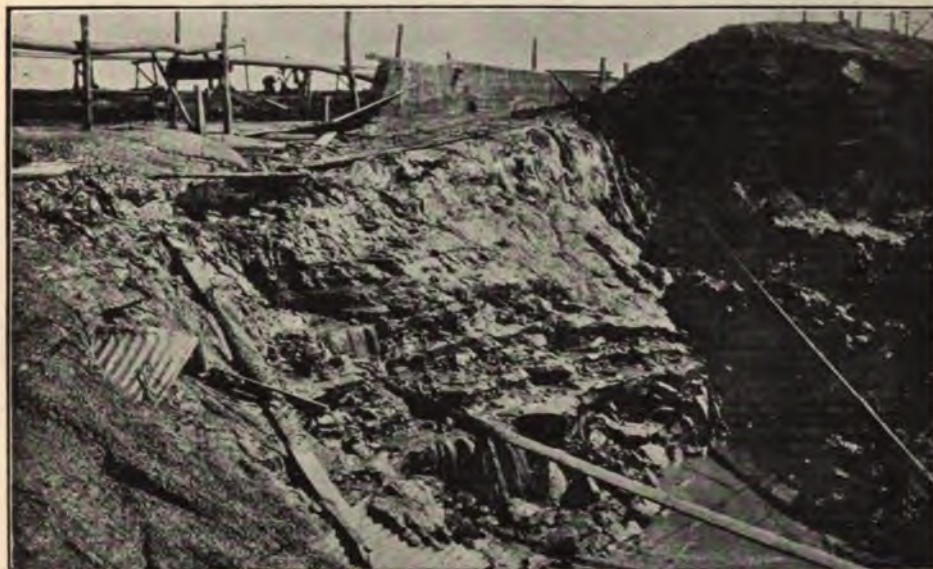
FIG. 377.—ILLUSTRATING THE COMPACT CHARACTER OF THE CLAY CORE OF THE SANTO AMARO DAM, ACCIDENTALLY EXPOSED TO VIEW BY A BREAK FROM THE POND ON TOP OF THE DAM.

The remarkable picture shown in Fig. 377 is the best possible demonstration of the effect of hydraulic sluicing in the segregation of pure clay from a mass of coarser materials, and its deposit in a condition of stable solidity within a short time. It is a picture of the clay core of the Santo Amaro dam accidentally exposed to view by a break in one of the lateral levees, the effect of which was to empty the pond on the dam and wash

away the levee and its supporting base of coarser material for a distance of about 50 feet. The break, which occurred in the up-stream slope, caused the loss of 400 cubic yards of material, but the demonstration of the stability of the clay core, none of which had been deposited three months, and some of it but a few days, was worth far more than the loss. The clay as exposed was left standing almost vertically, and it had successfully withstood the wash of water pouring over it from the emptying of a pond several hundred feet long, 50 to 60 feet wide, and 2 to 4 feet deep, with comparatively slight erosion. The break was caused by the saturation of the levee, built of material brought in by cars, which, not being sluiced and assorted, the finer particles from the

The conditions of solidity and maturity in the clay core shown in this case is a most reassuring endorsement of the superiority of the hydraulic sluicing method of dam construction.

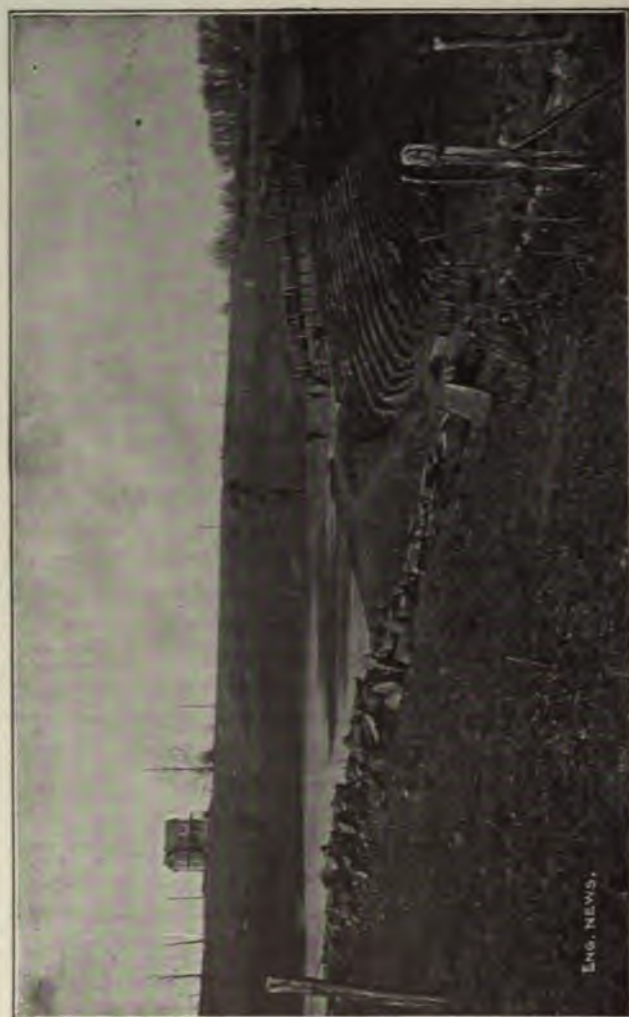
FIG. 381.—Roland Park Hydraulic-fill Dam, Baltimore, Md.

and the building of a small dam is described in *Engineering News*, June 11, 1908. The grading of the hill required the removal of 50,000 cubic yards of earth. This was placed in a dam 400 feet long, 24 feet high, all of which was constructed by the hydraulic process, the earth being
